## RADIATION AND VIDEO SURVEY OF WATER CLEANUP AND VENTILATION SYSTEM OF RFT REACTOR

**Abstract.** The specialists of NRC “Kurchatov Institute” have conducted the dismantling of the MR multiloop research reactor and RFT reactor. The technical start-up of the 20 MW capacity experimental graphite water cooling reactor (RFT) started in 1952. The reactor was shut down 10 years after the working period. The fuel was removed and the reactor was partially dismantled. The ventilation system and water cleanup system of the RFT reactor were located in a separate building. The upper part of the reactor vent stack was dismantled in the early 60's. The water cleanup system, which consists of 6 stainless steel tanks (4 – Ø1.5m, h=5m; 2 – Ø3m, h=5m) located around the base reactor vent stack, was mothballed. To plan the dismantling work, a radiation and video survey of the water cleanup system and the reactor vent stack was carried out. For this purpose, holes were drilled in the upper ceiling of premises with the water cleanup system and at the top of vent stack. Through these holes video recording and measurement of the exposure dose rate distribution were carried out. The measurement of the e

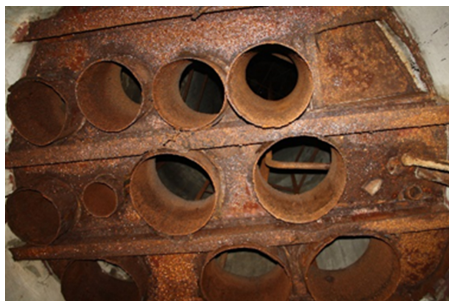
For the inspection of the internal volume of the vent stack in the stack wall at a height of 1.5m from the floor above the premises of the tanks, a hole  $\varnothing 150\text{mm}$  was drilled. Video inspection inside the vent stack was carried out through this hole. The survey showed that inside the stack there are metal structures, at the bottom of the vent stack, partially dismantled nozzles. Also the photos were taken from the stack space under the nozzles. In Fig.5, photos of nozzles located in the lower part of the vent stack and metal structures, which are visible through the nozzles, are given.

Figure 5. The photos of nozzles (upper) located in the lower part of the tube and metal structures (lower)

After the removal of metal structures inside the vent stack, it is necessary to re-measure the surface radioactive contamination of the vent stack to clarify the depth of penetration of radionuclides into the concrete [7]. Knowing the thickness of the contaminated layer can significantly reduce the amount of radioactive waste. Various technologies of removal of radioactively contaminated concrete layer from the surface of the vent stack are considered.

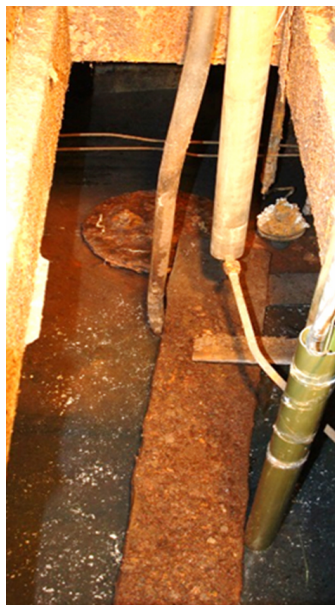
Montejus 1 and 2 are at the bottom of the building in the canyon under the vent stack. These montejus merged water from the adsorption columns, the activity of which exceeded the norm. The water from these montejus came back to the adsorption column for repeated purification. Currently, the canyons are filled with water. In Fig. 8, a photograph of the canyon montejus filled with water is showed.

Figure 8. The photo of the canyon with montejus

Montejus and pipelines in the canyon are covered with a layer of rust. The gamma dose rate on surface of canyon is 0.2mSv/h.

From the canyons, which are located in montejus, it is necessary to remove radioactive water that will allow a detailed radiological survey of canyons and montejus and the optimization of their dismantling.
